Bluewrist Case Study

100% Inline Seating Inspection for Unseated Connectors

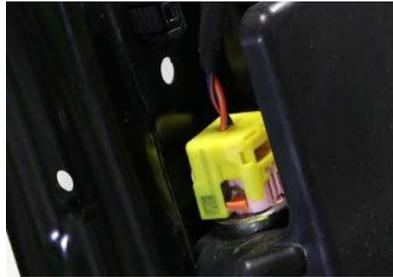
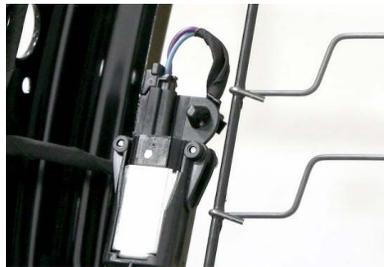
Various connectors, point cloud and inspection results

cameras to capture a point cloud image. The cameras are now capable of detecting different types of defects, such as soft set connectors that can come apart with road vibrations or open and missing clips. In tandem, ScanX-tream software analyzed the 3D point cloud of the clips and connectors to check for various types of defects. To verify correct installation and clip engagement, Bluewrist 3D vision algorithm compared the 3D point cloud data to the correct predefined reference position.

SPCWorks then collects, analyzes, and displays the results for the end user. The results of the inspection are displayed graphically to help quality assurance personnel identify issues immediately and rework defective components.
