Bluewrist Case Study

Inline Vehicle Roof Weld Inspection

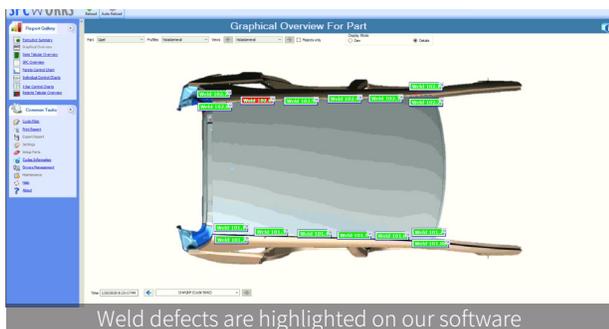
a total of eight times on each side of the roof. After each weld is scanned, the data is sent to the SPCWorks database so that data can be analyzed progressively in parallel fashion, thereby reducing the overall processing time required.

As the vehicle body enters the inspection area, the robot scans the roof welds while staff sequentially check the welds. The weld is scanned at 200 mm intervals at a speed of 150 mm per second and then processed in real-time, a process that is carried out

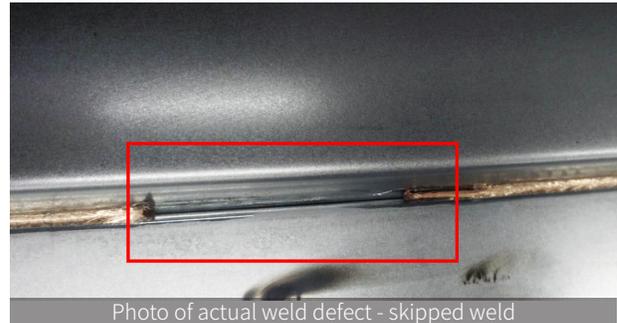
The entire process can be completed in 34–36 seconds. Once the scanning process is complete, the assembly line diverges based on the results of the inspection. If the scan shows the component is produced correctly, a QR code is printed on to the car body, and the PLC is then triggered to send the body along the production line to continue the assembly process. If the welding does not pass the quality assurance stage, a QR is still printed on the vehicle, but the body is sent to the rework station.
